Business Unit:	Safety & EMC Group
Report Title:	Investigation of LTE UE interference into Social Alarms
Author(s):	Z Wang, S Antwi, S Munday
Client:	Ofcom
Client Reference:	Mark Austin
Report Number:	2011-0492
Project Number:	7A0694801
Report Version:	FINAL

This report examines the potential for interference to social alarm systems from Long Term Evolution (LTE) user equipment (UE) operating in the 800 MHz band. The study tests the performance of an example social alarm in the real-life environment of a residential flat in a sheltered housing complex.

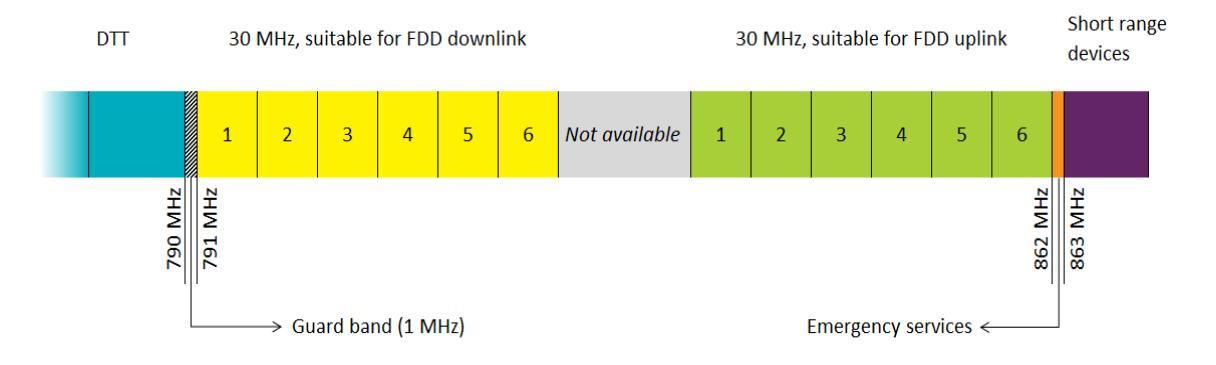
Figure 1: 800 MHz band plan

The harmonised frequency arrangements for the 800 MHz band are set out in ECC Decision 2010/267/EU [2], based on Frequency Division Duplex operation with the downlink located in the lower part of the band, from 791 – 821 MHz, an 11 MHz duplex gap between 821 – 832 MHz and then the uplink located from 832 – 862 MHz. The band plan is illustrated in the figure below.

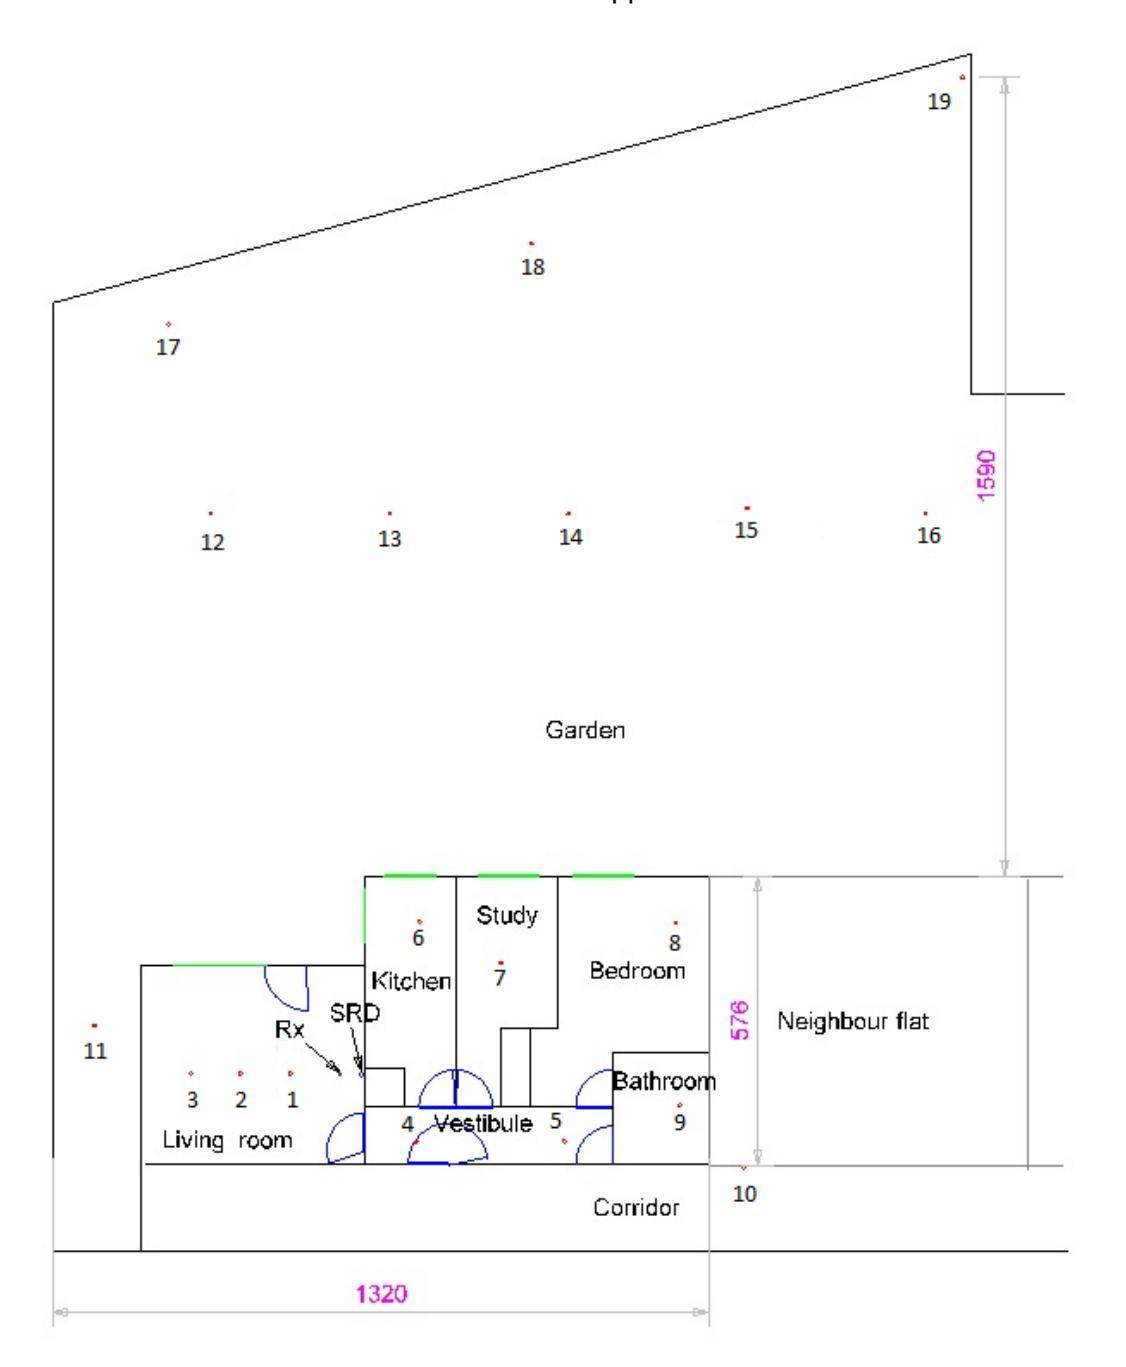
Figure 2: Plan view of test flat with measurement locations (units in cm)

The measurements were undertaken in a ground floor flat and communal garden that forms part of a social housing complex in the London Borough of Lambeth. The layout of the flat and the test locations are shown in the following figure. The distance between each location and the social alarm hub unit is included in Appendix A.6.

The flat is of standard construction, with brick walls and double glazed windows looking out onto the communal garden. The front door is accessed from a communal corridor and opens into a vestibule which connects the living room, the kitchen, a small study, the bedroom and the toilet/bathroom. There are two small storerooms located next to the kitchen and the study. Ceiling height is 2.26m.

The social alarm hub unit (base station) was installed in the living room (marked as SRD in Figure 2) next to a wall. The unit was connected to the Lambeth Telecare centre using a standard telephone connection.

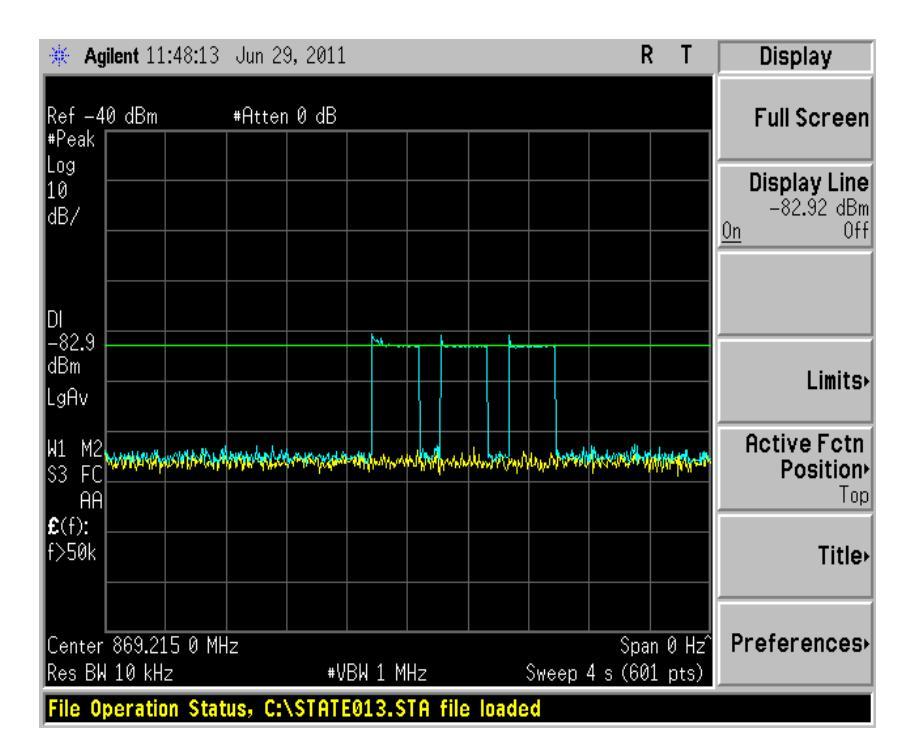
Figure 4: Trigger pulse from social alarm pendent (shown in time domain)

The trigger signal is shown in Figure 4, captured in the time domain. The signal comprises three pulses, each pulse is about 0.3 second wide with a delay of 0.1 seconds between pulses. However it should be noted that according to the alarm manufacturer, each of the three pulses repeat the same information and only one pulse needs to be received to trigger the alarm.

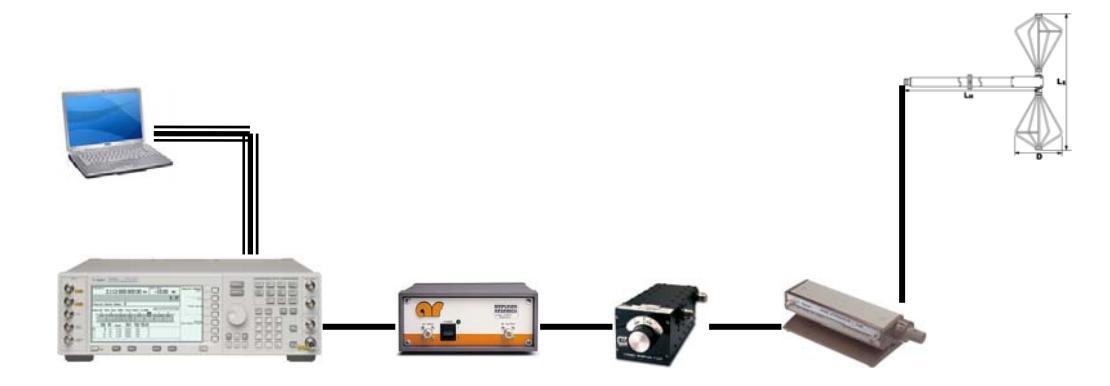
Figure 5: Generation of LTE UE interferer

The captured signal was played back through a signal generator and amplified by an overdriven amplifier to create spectral re-growth. The signal was then filtered such that the resultant spectral emission mask conformed as closely as possible to the out-of-band requirements for FDD terminal stations defined in Table 2. The transmit power was controlled using a variable attenuator to step the entire mask up or down, thus maintaining the same Adjacent Channel Leakage Ratio throughout the testing. The equipment setup is shown in Figure 5 below.

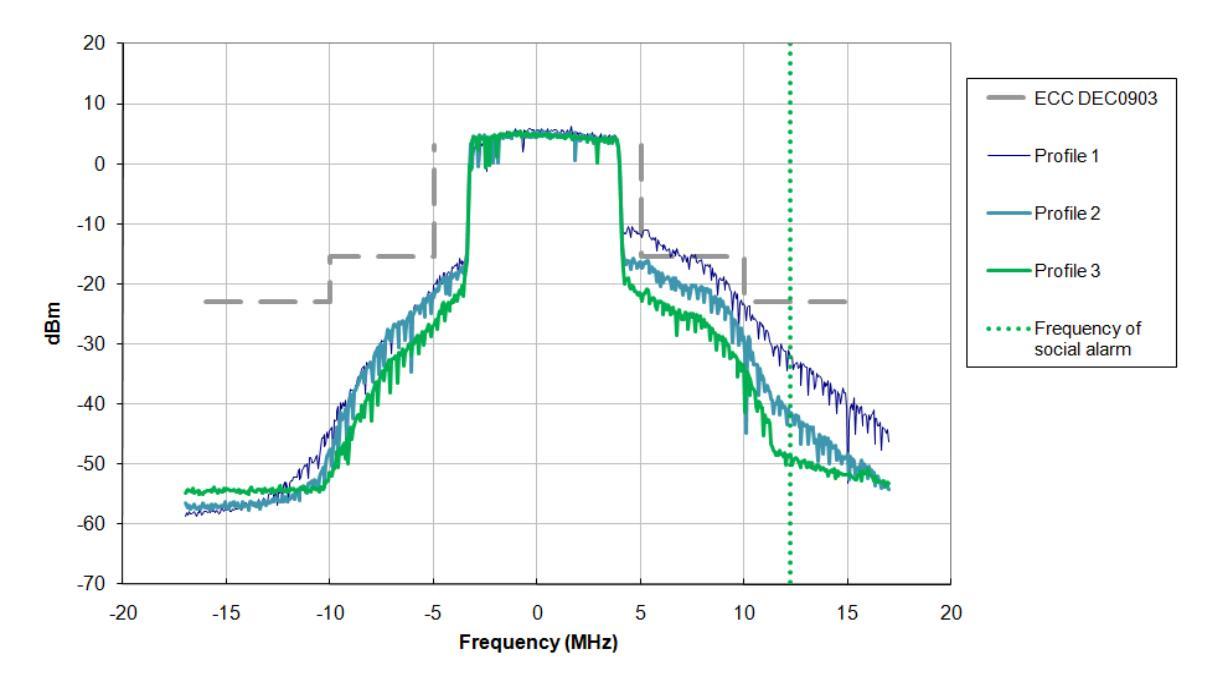
Figure 6: Spectral emissions of LTE UE Profile 1, 2 and 3: 20 Mbits/s (100 kHz RBW)

- Profile 1: 20 Mbits/s data throughput, 23 dBm/10 MHz in-band power, OOB emission mask tuned to match the ECC/DEC/(09)03 requirement;
- Profile 2: 20 Mbits/s data throughput, 23 dBm/10 MHz in-band power, OOB emission mask tuned to be 5 dB below the ECC/DEC/(09)03 requirement;
- Profile 3: 20 Mbits/s data throughput, 23 dBm/10 MHz in-band power, OOB emission mask tuned to 10 dB below the ECC/DEC/(09)03 requirement;

The spectral emissions of these profiles are shown in Figure 6 and Figure 7 below, along with the mask of ECC/DEC/(09)03.

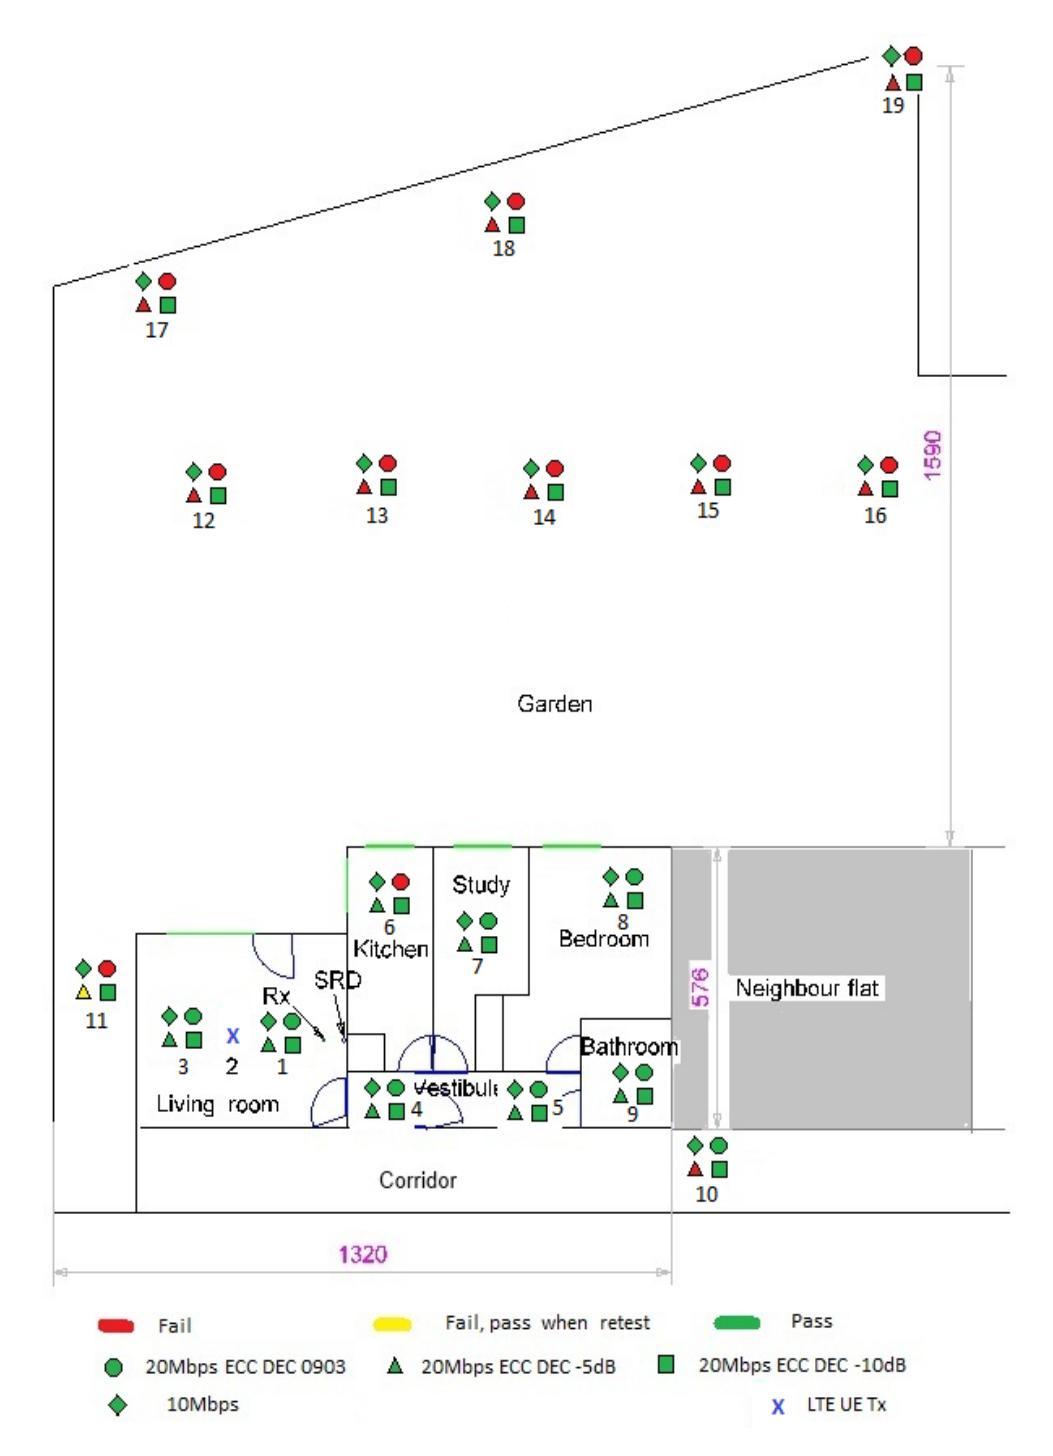
Figure 8: LTE UE at location 2, pendant triggered from standing position

Figure 8 and Figure 9 show the results for the UE in the living room, 2m from the social alarm hub unit (location 2), and the alarm triggered from either a standing or kneeling position at a number of different locations. The results show that when the UE was operating at 20 Mbits/s, with out-of-band emissions close to the ECC/DEC/(09)03 requirement, there were two locations inside the flat where the alarm failed to trigger (locations 6 and 9). The alarm also failed to trigger from the corridor and any location in the garden.

When the UE OOB emissions were reduced to 10 dB below the ECC requirement the alarm was successfully triggered from all locations inside the flat and corridor. Similarly for the garden, when the UE OOB emissions were assumed to be 10 dB below the ECC requirement then the alarm was successfully triggered from all locations except the very furthest point in the garden (location 19) when kneeling.

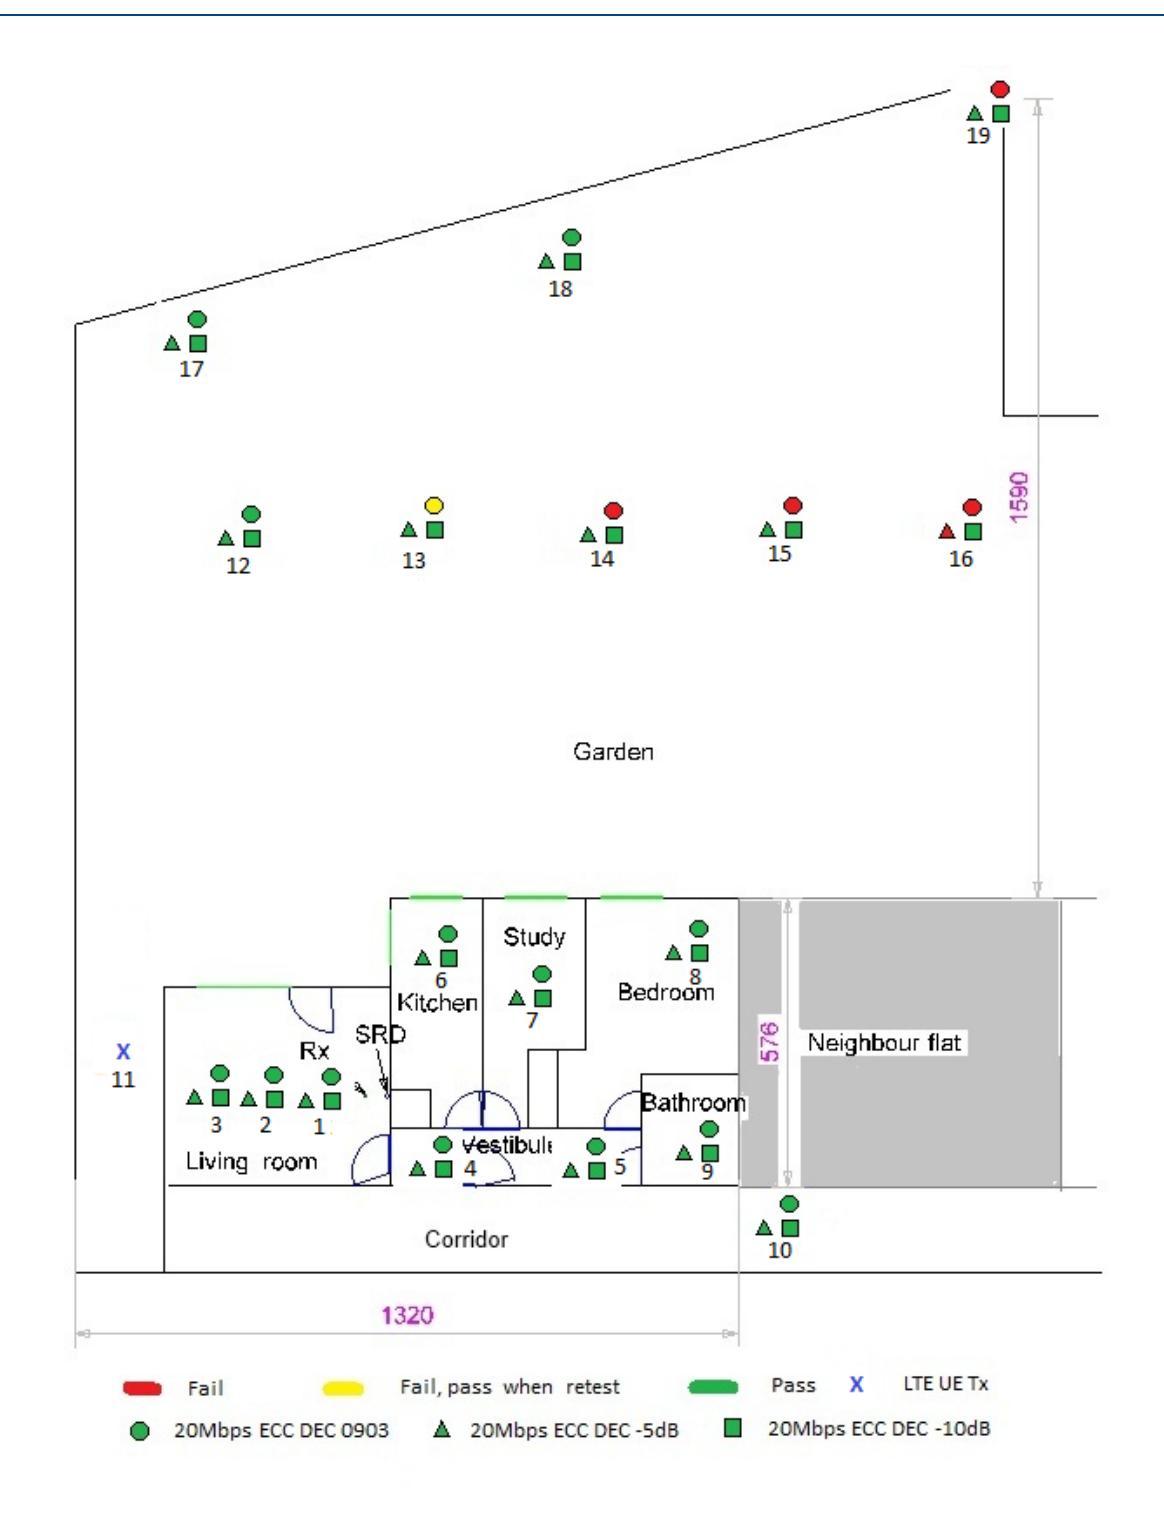
Figure 10: LTE UE at location 11, pendant triggered from standing position

Figure 10 shows that when the LTE UE was moved to the garden, near to the living room wall (representing an LTE user outside the premises), the alarm was triggered from all locations inside the flat regardless of the level of the OOB emissions. However, the alarm failed to trigger from 50% of locations in the garden unless the OOB emissions were reduced to be 10 dB below the ECC requirement.

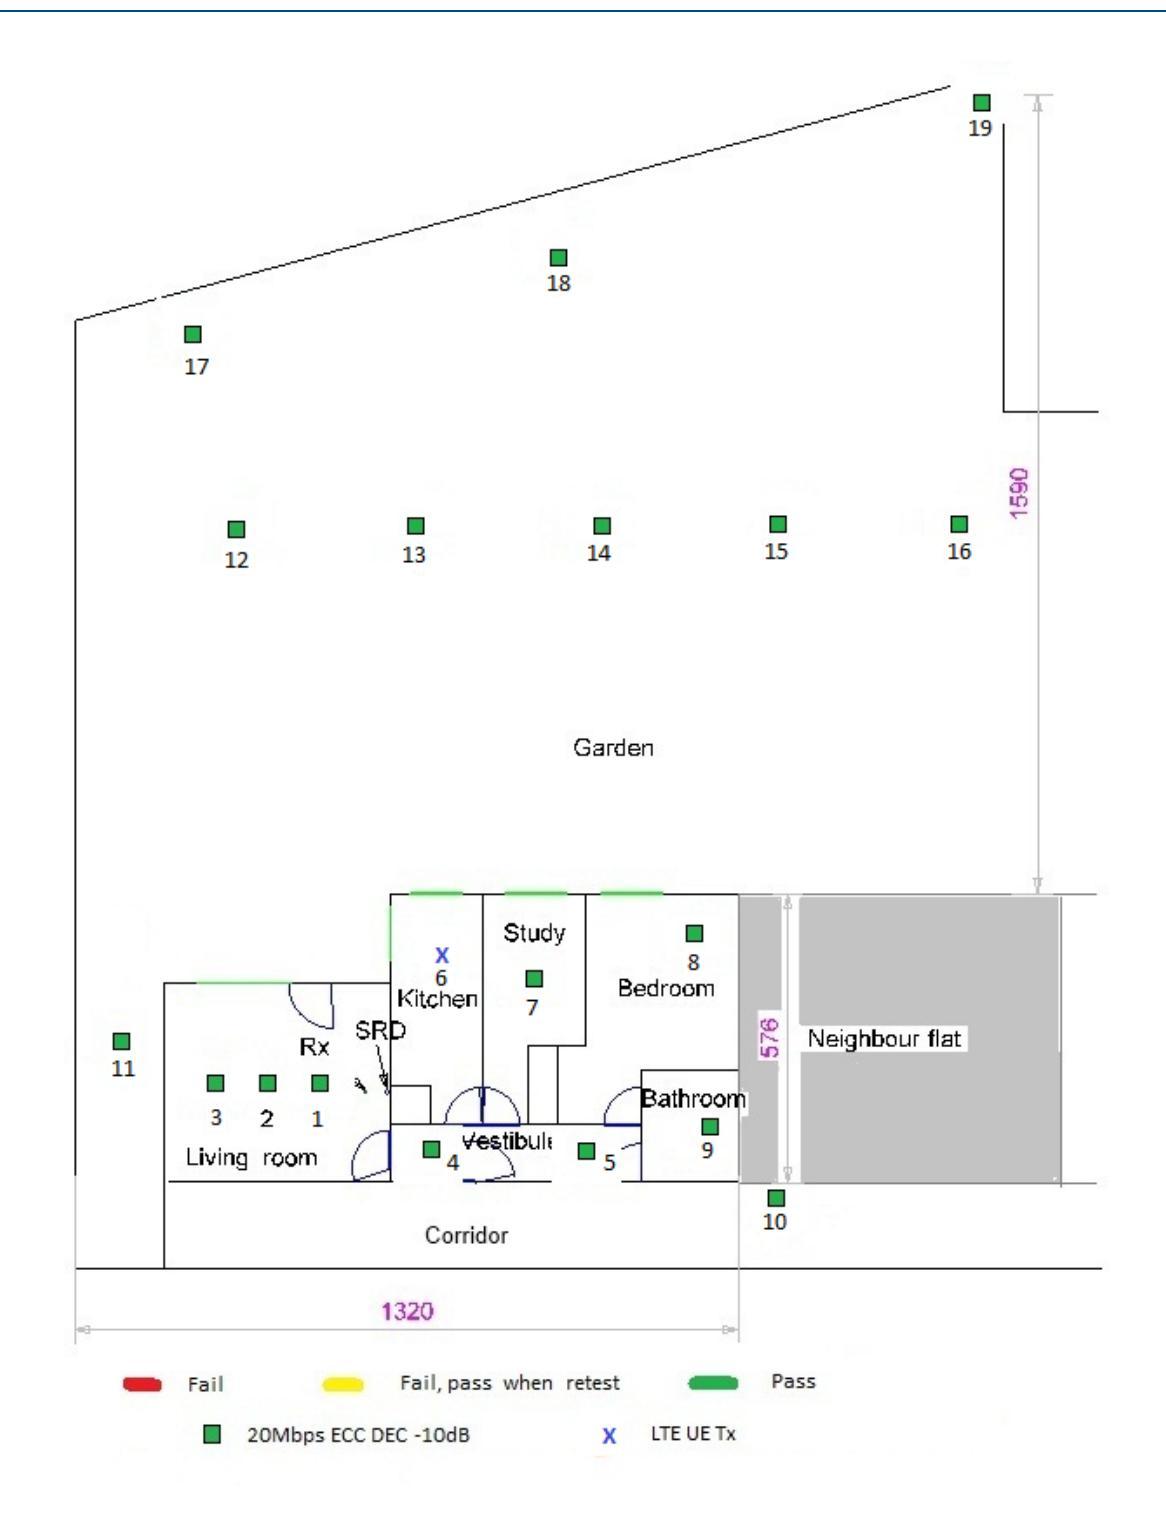
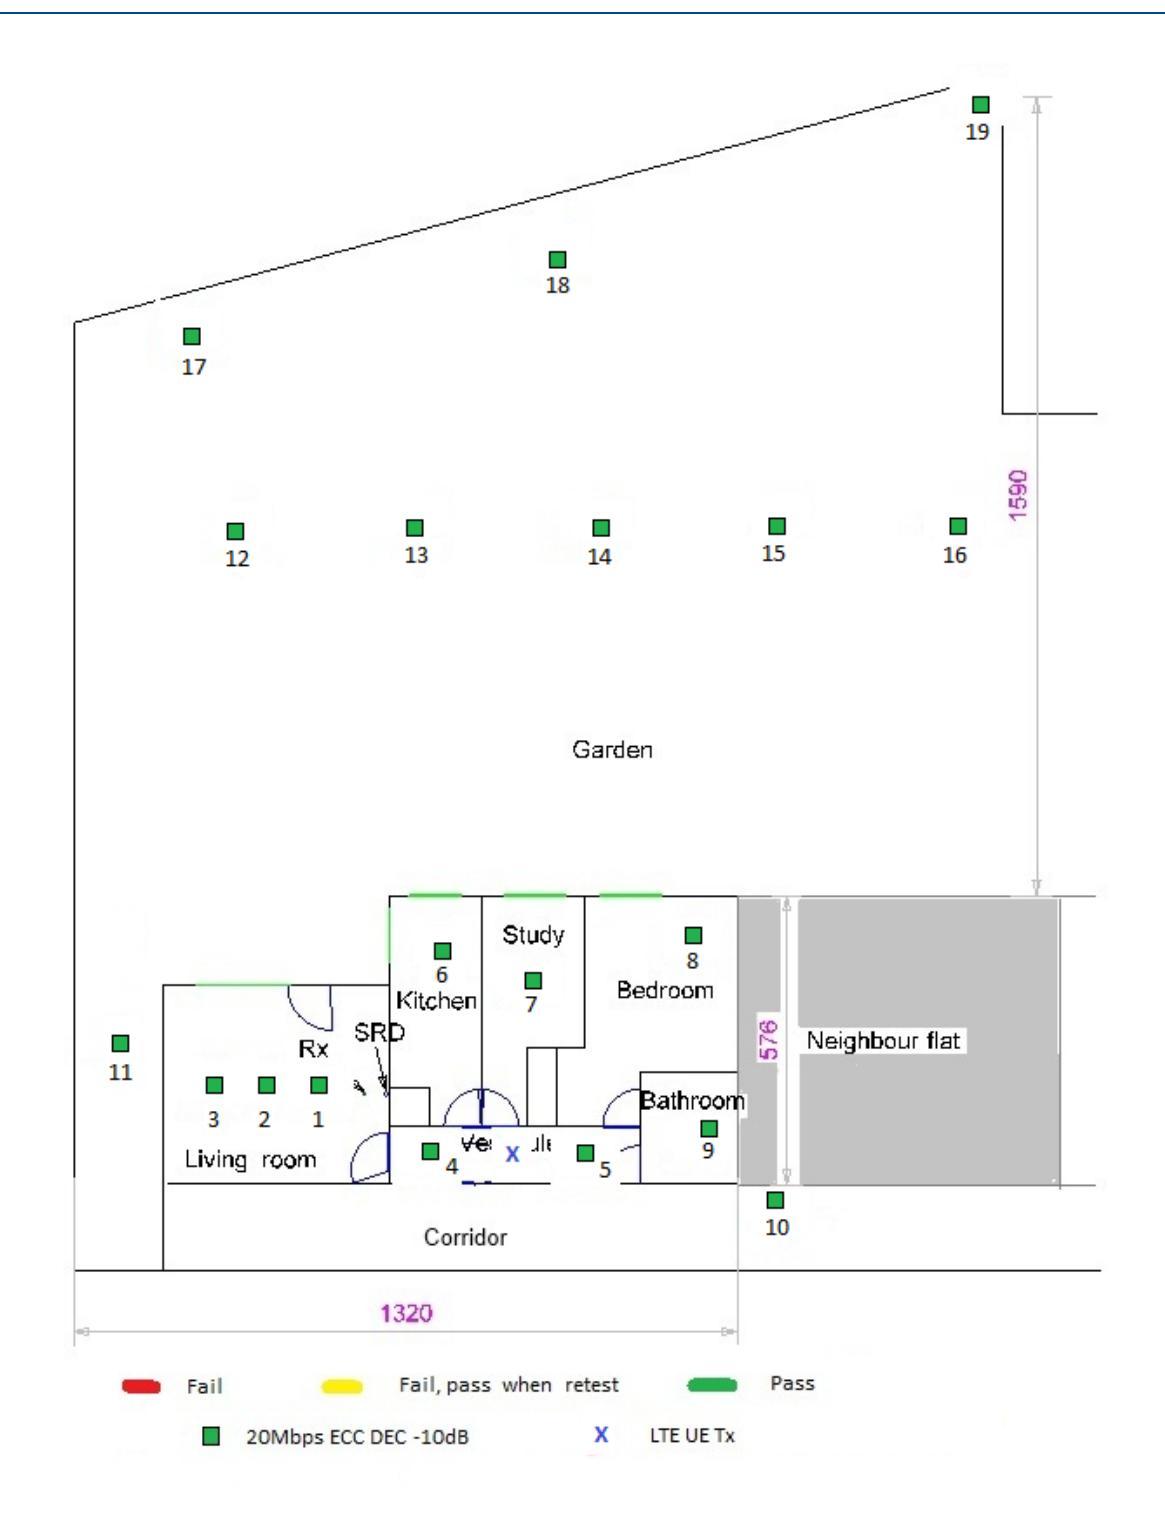
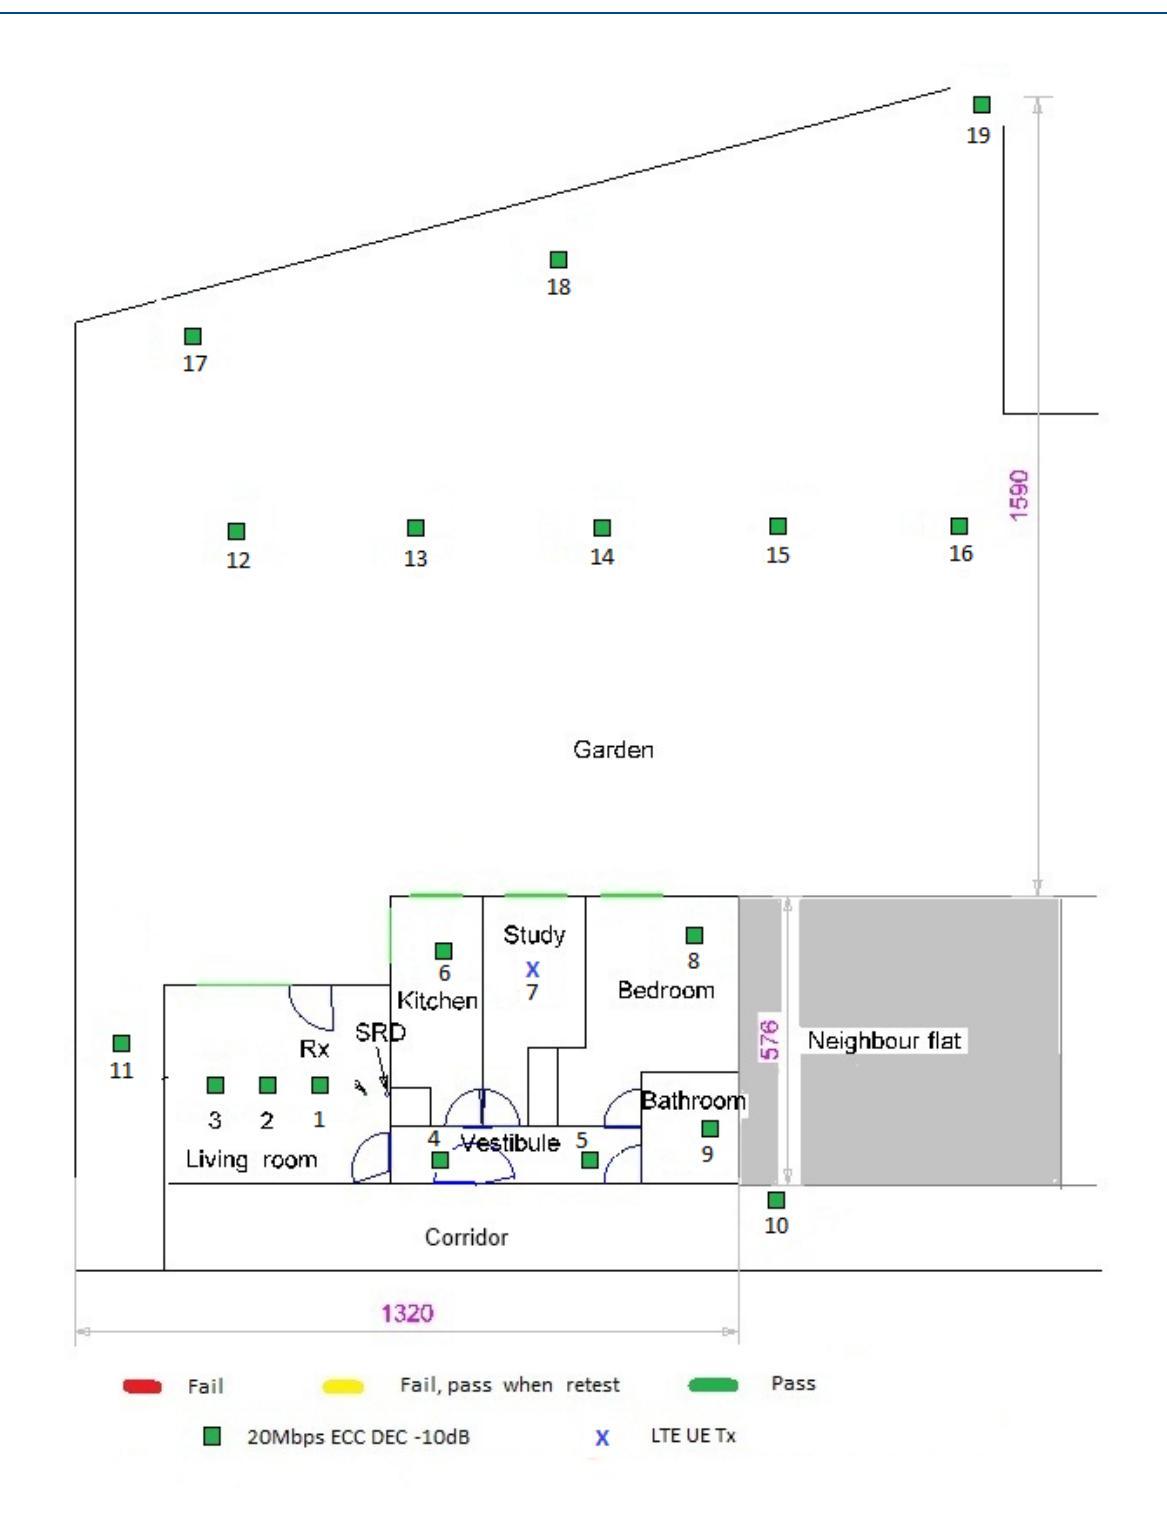
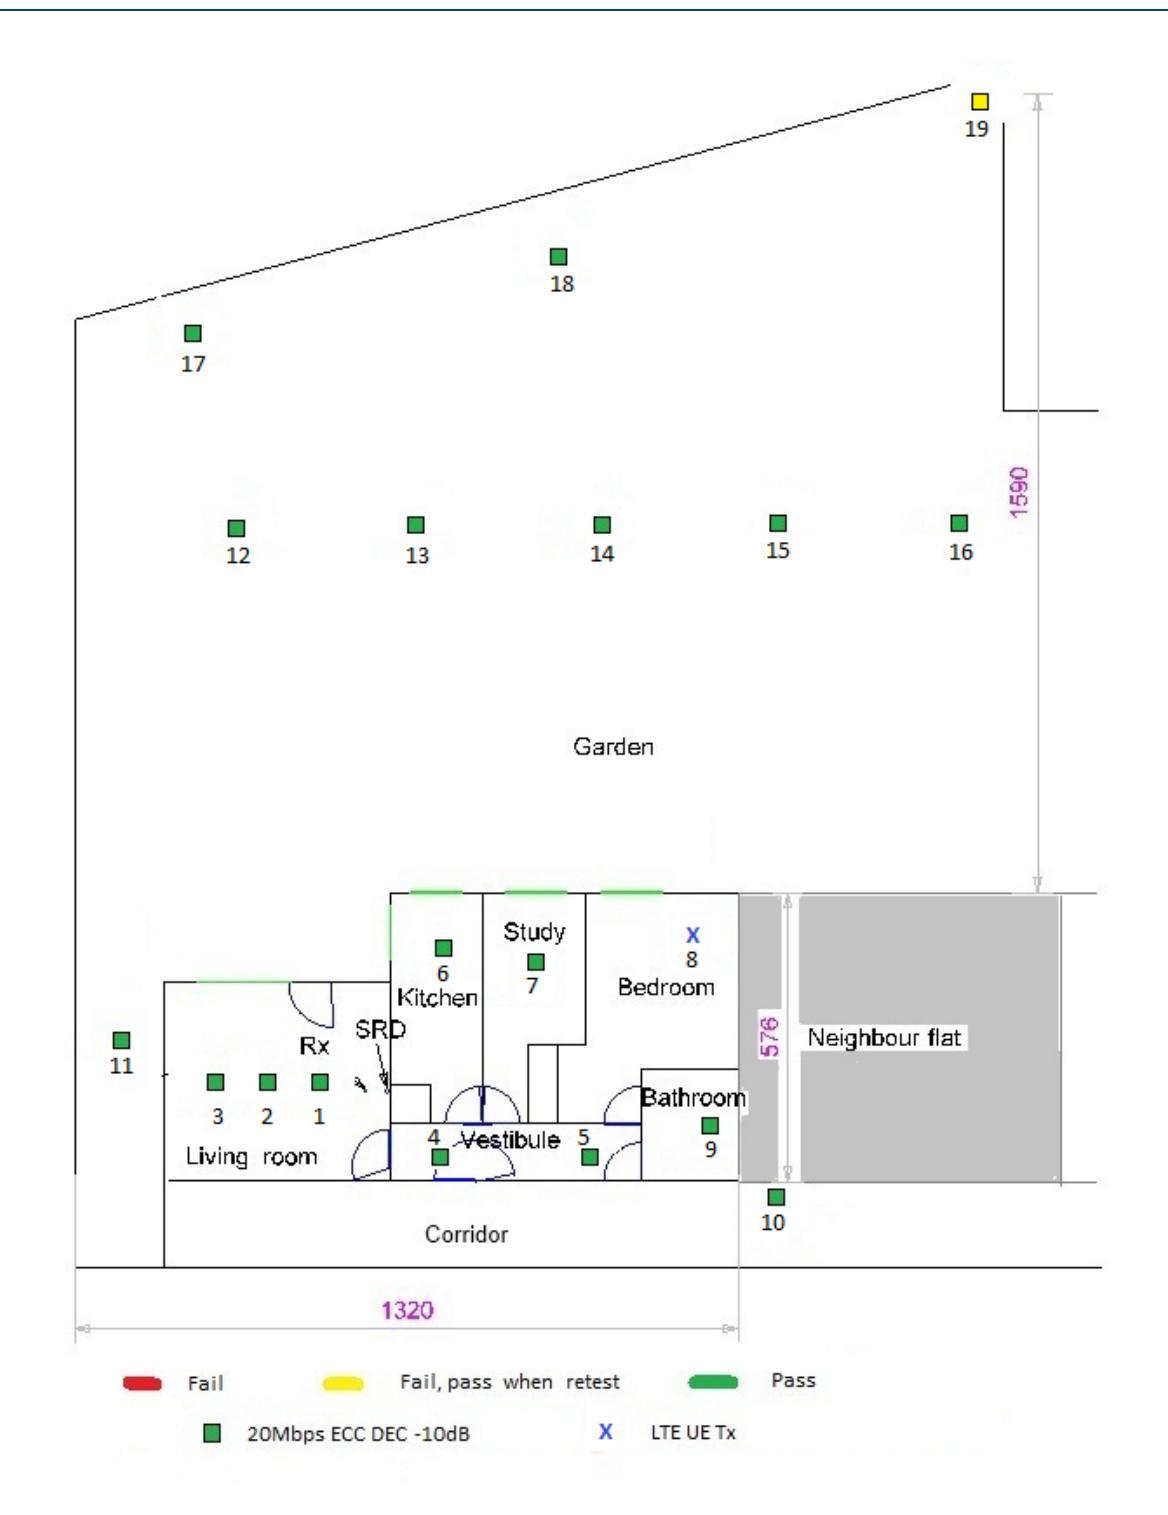
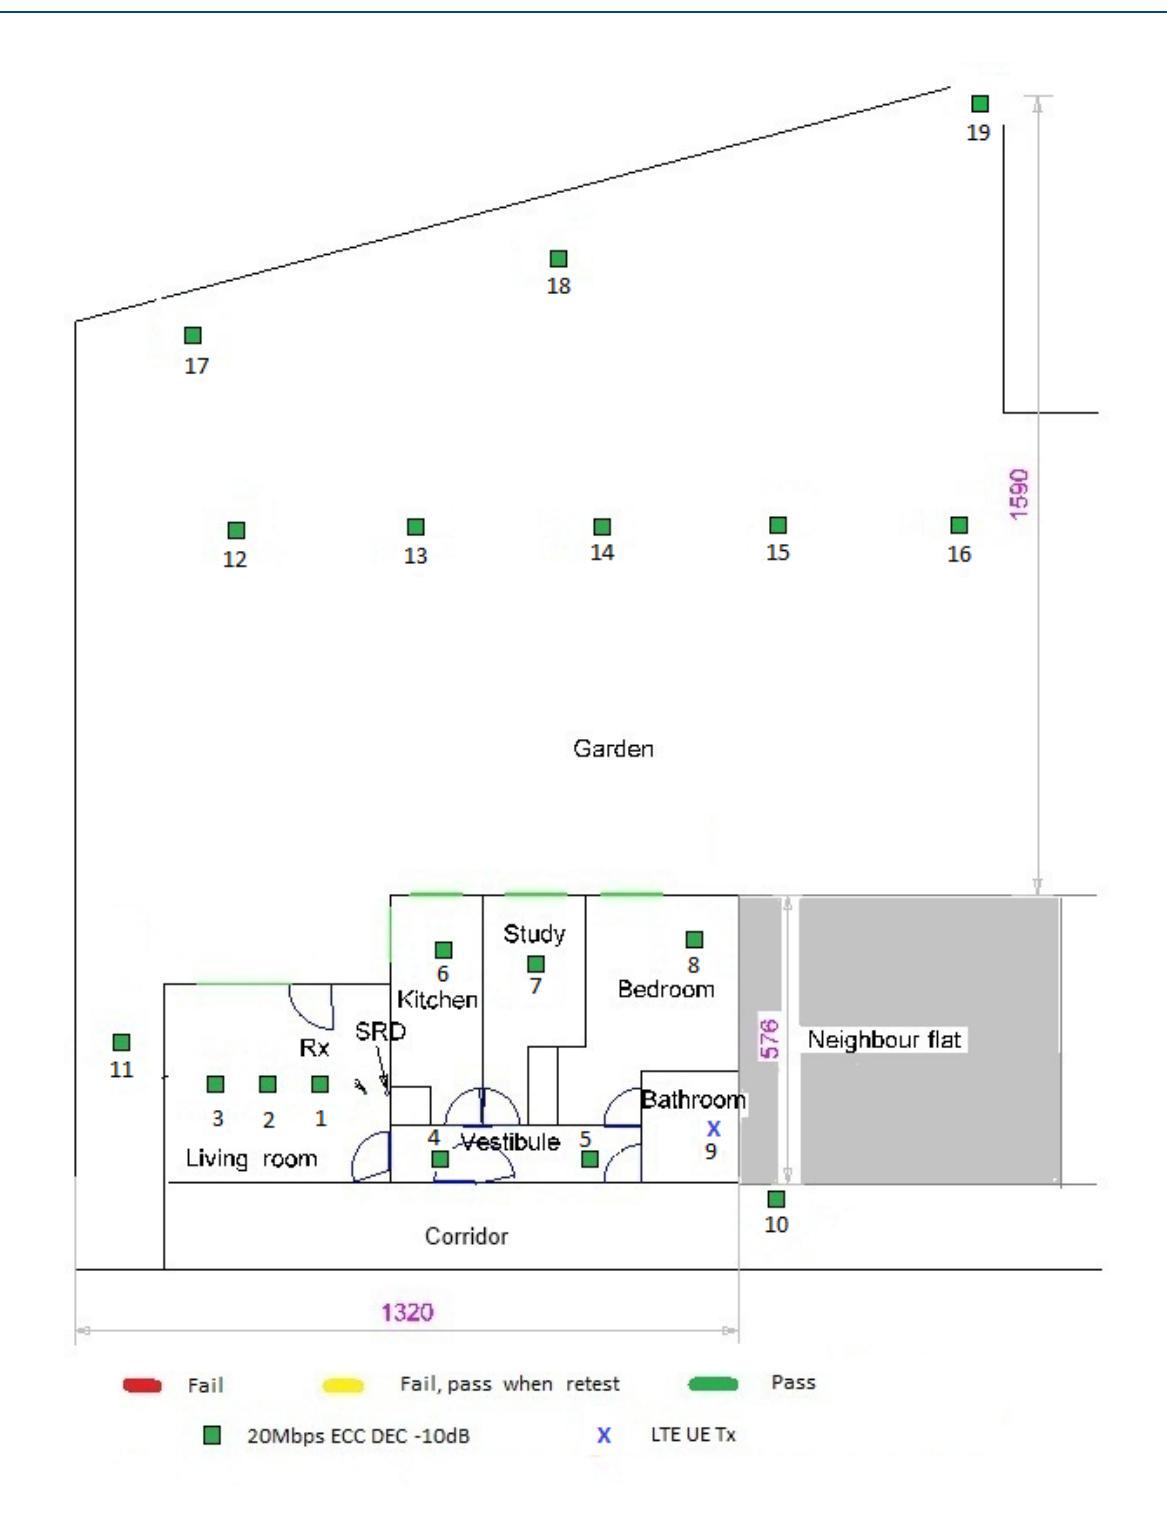
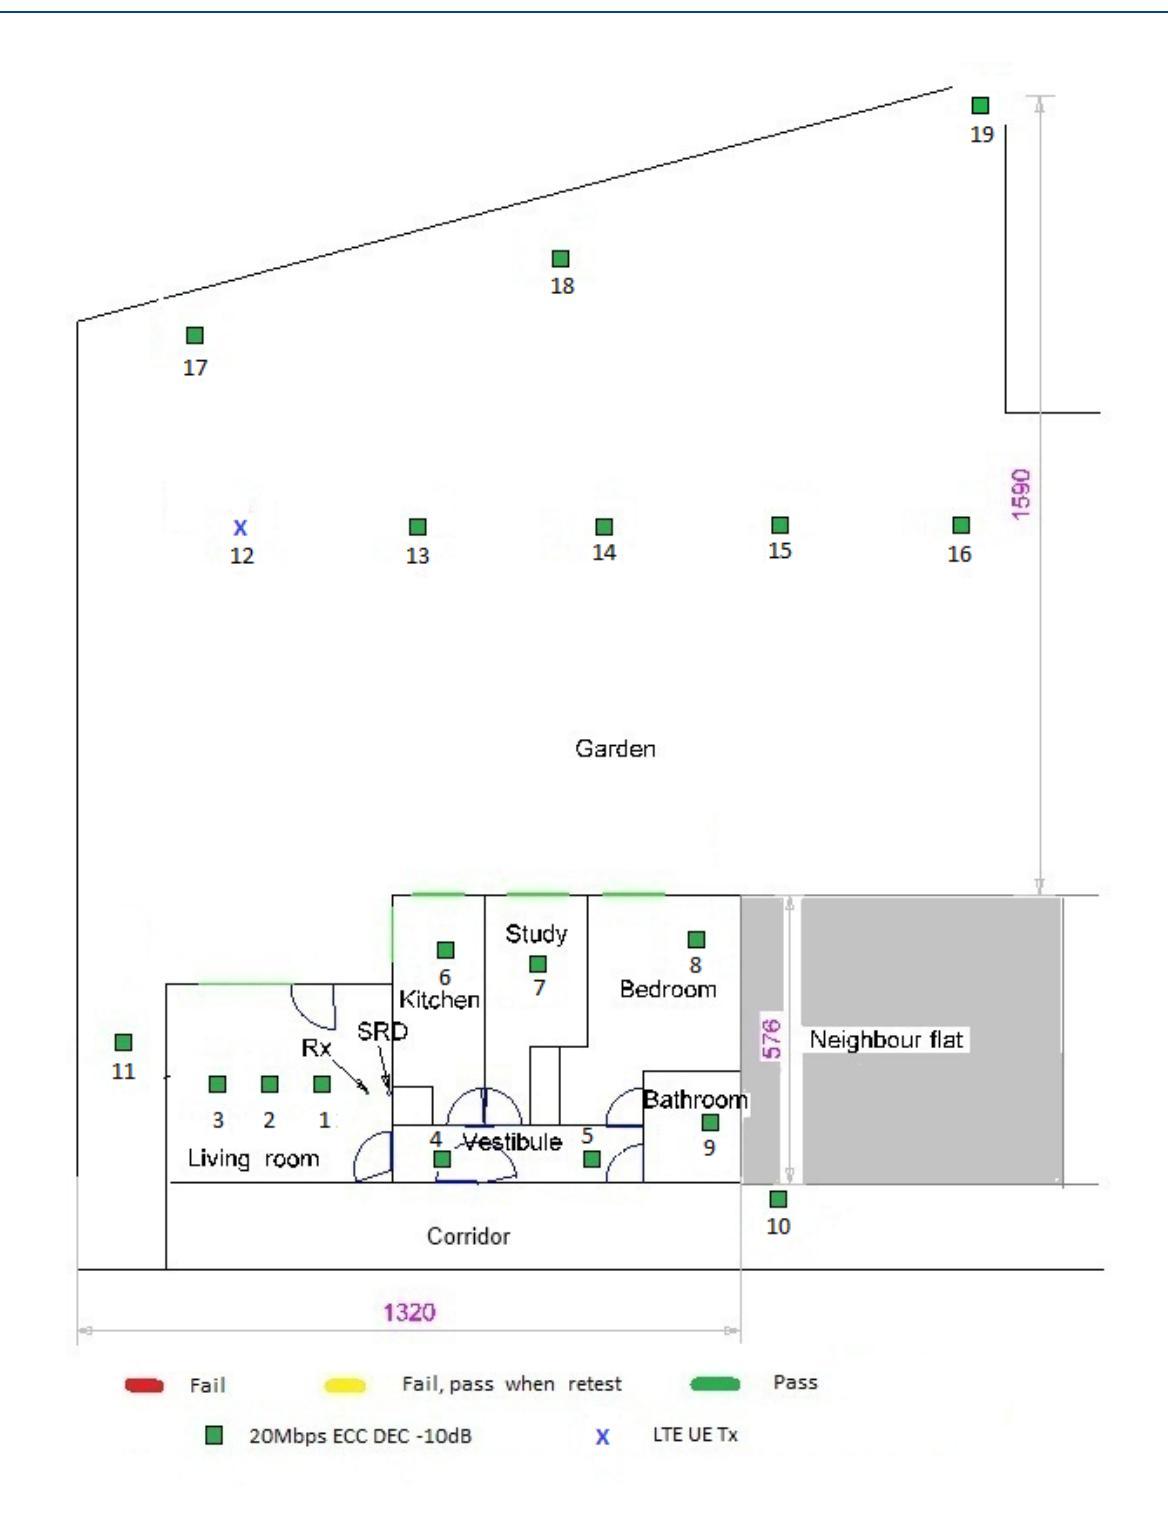
Figure 12 through to Figure 17 show that when the LTE UE was placed at other locations in the flat and garden (representing an LTE user in neighbouring rooms or premises), with 20 Mbits/s data throughput and OOB emissions 10 dB below the ECC requirement, the alarm was successfully triggered from all locations.

When the LTE UE was placed at other locations in the flat and garden, with OOB emissions 10 dB below the ECC requirement, the alarm was successfully triggered from all locations. This is most likely due to a combination of the lower OOB emissions and reduced interfering signal strength received at the social alarm hub unit due to increased separation.

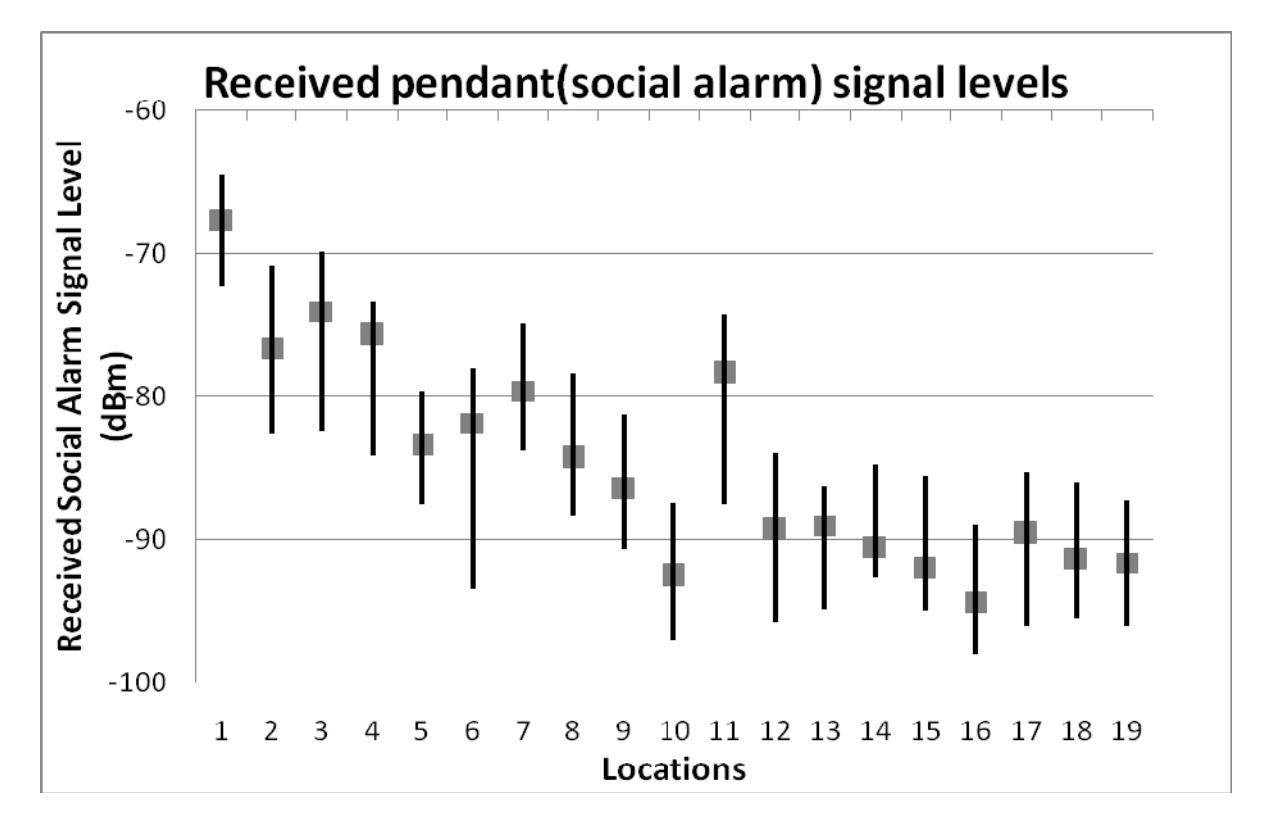
Figure 18: Received Social alarm pendant signal levels

The received social alarm pendant signal level from the locations around the flat is shown in Figure 18. The square mark represents the average received signals (from standing positions) at the location, and the vertical line represents the range of the received signal level.

It can be seen that the signal level varies by around 10 dB. This could be due to a combination of the following factors:

- The orientation of the pendant; the effects of polarisation orientation can introduce 15 dB difference, as detailed in section A.3
- The body attenuation losses, as detailed in section A.2
- The receiving antenna was not co-located with the antenna of the social alarm hub unit; a 45cm distance was maintained between the two antennas to reduce the effects of any coupling loss. Although this may change the overall signal level, it would not be expected to significantly affect the variation in signal level.

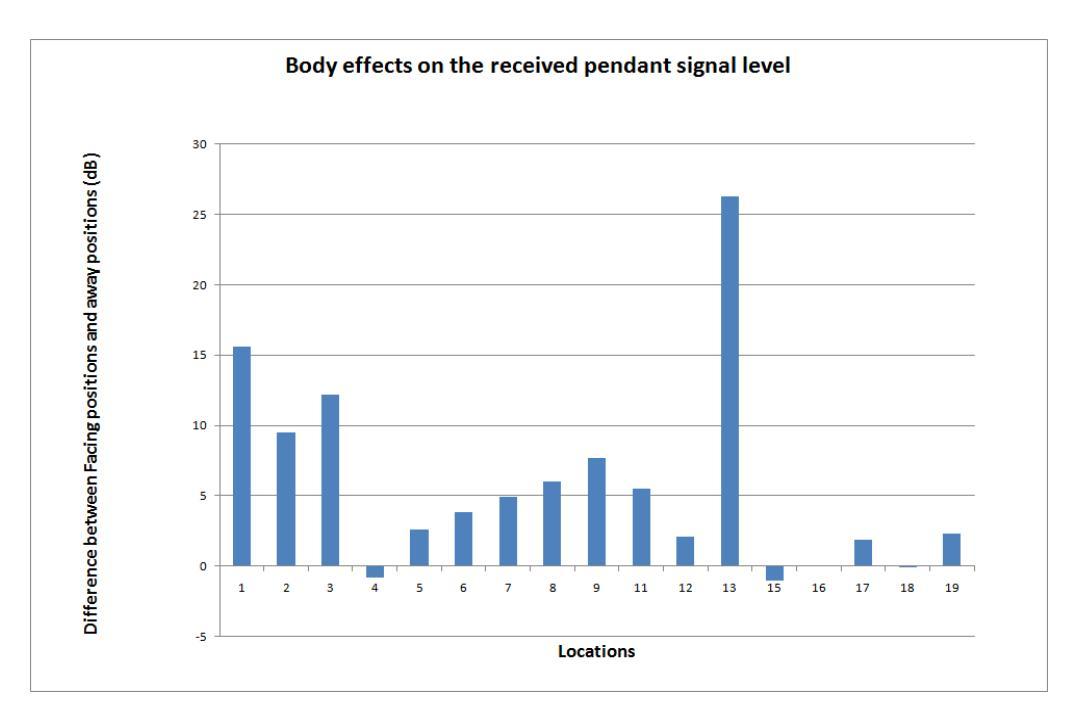
Figure 19: Body loss (Subject A) effects at different locations

Subject A in Table 3 was used for all other testing in this report and Figure 19 below shows how the body loss varied at different measurement locations (Note: no measurements were made at location 10 or 14).

In all cases the body loss was calculated from the delta between received signal strength at the social alarm hub with the test subject facing towards the hub and then facing away from the hub. This assumed the dominant propagation path was the direct path between the test location and the hub. The large range in values for body loss at different locations indicates that this was not the case and that other reflected or diffracted paths may have been the most significant.

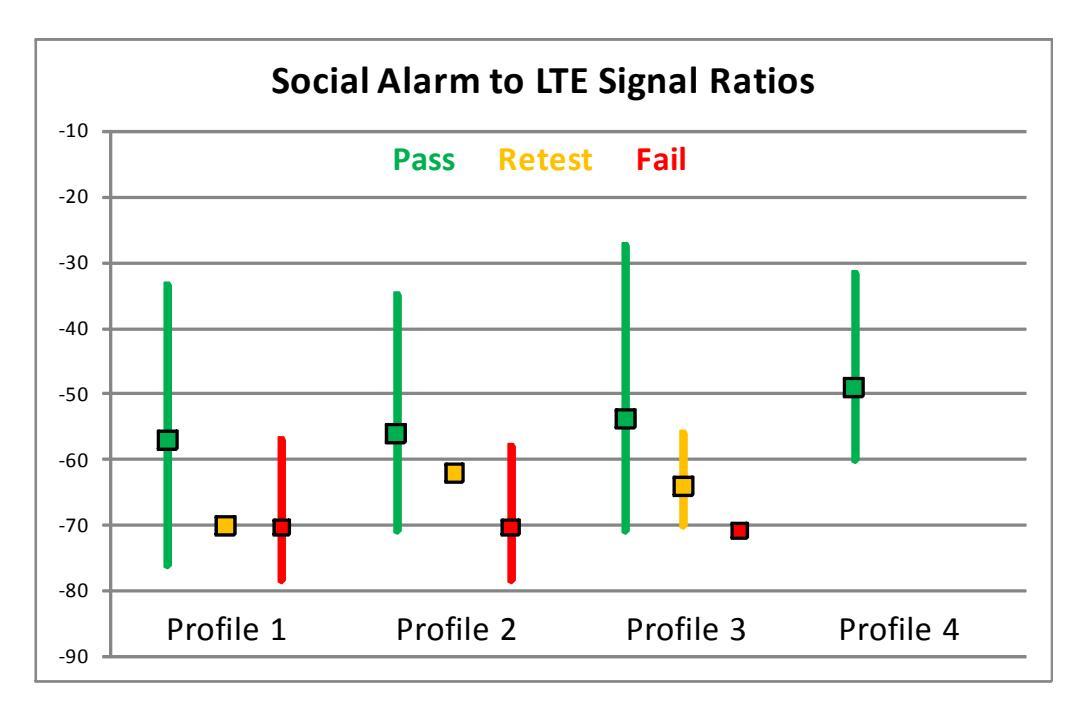
#### Figure 20: Social Alarm / LTE measured ratios

Figure 20 shows the measured social alarm versus LTE signal level ratios for all profiles as detailed in the following subsections. It can be seen that there is some overlap between pass and fail, indicating that it is not entirely blocking caused by the presence of the LTE signal that prevents the social alarm from triggering and that the impact of the LTE modulation and time varying signals may also have some effect.
